PANHARD ROD CLEARANCE NISSAN PATROL GU

Y61 Nissan GU Patrols (all models) fitted with the large spherical bushing in the chassis end of the Panhard Rod can experience a clearance issue at full compression of the coil spring. In a factory standard vehicle the radius arm will come into contact with the Panhard mount creating metal to metal contact.

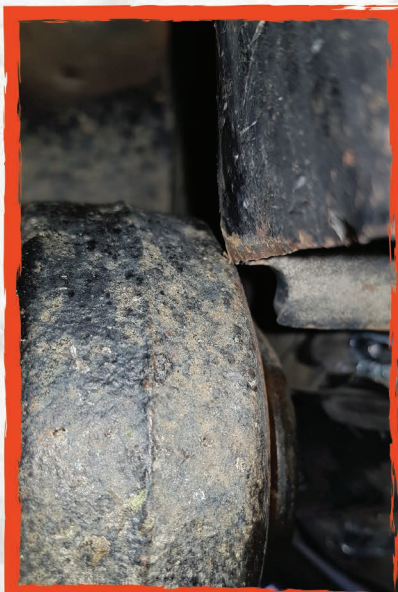
Image shows the interference between the radius arm and chassis Panhard mounting bracket.

Roadsafe has established that this is happening with a factory radius arm in the factory mounting position close to bump contact (this illustration is not at full bump - another 2" to bump stop compression, coil springs have been removed in this illustration)

It must be noted that this vehicle has the spherical bush in the Panhard rod which does make the chassis bracket wider thus could be creating this issue.

Some Roadsafe products listed below move the diff forward, as per the design, and have the potential to exacerbate the factory clearance issue. A possible fix for some customers (lifted height consideration) is to increase bump stop length.

We do not recommend a specific length of extension as this will be a variable based on shock length, spring height, tyre size could be a factor.

A good rule of thumb is to have approximately 30mm of up travel remaining in the shock absorber at full bump stop. This allows for clearance based on the variable geometry of the suspension not compressing bump stops simultaneously when compared to offset with articulation.
