DAYCO AFTERMARKET TECHNICAL INFORMATION

T00001

TENSIONER ASSEMBLY
KTBA005, KTBA093, KTBA122, KTBA142,
KTBA149, KTBA244
ENGINES GM 1.6, 1.8 , 2.0 , 2.2

Motorisations: C16SEL, C16XE, X16XE, X16XEL, Z16XE, Z16XEP, C18XE, C18XEL, X18XE, X18XE1, Z18XE, Z18XEL, X20XE, X22SE, X22XE, Y22SE.

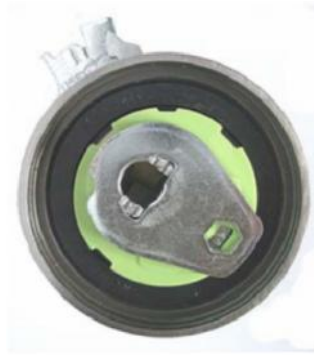
Fig. B

8) With the Allen wrench, rotate the tensioner anticlockwise until the maximum tension is obtained. The indicator should be on the right-hand side of the plate, as shown in **Fig. B**

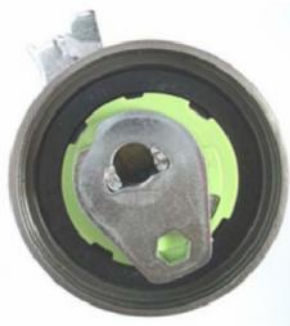
Fig. C

11) Loosen the tensioner bearing, and then rotate the cam clockwise with the Allen wrench until the indicator is aligned with "X".

The hexagonal hole should be in the ± 5 o'clock position, as shown in **Fig. C**.

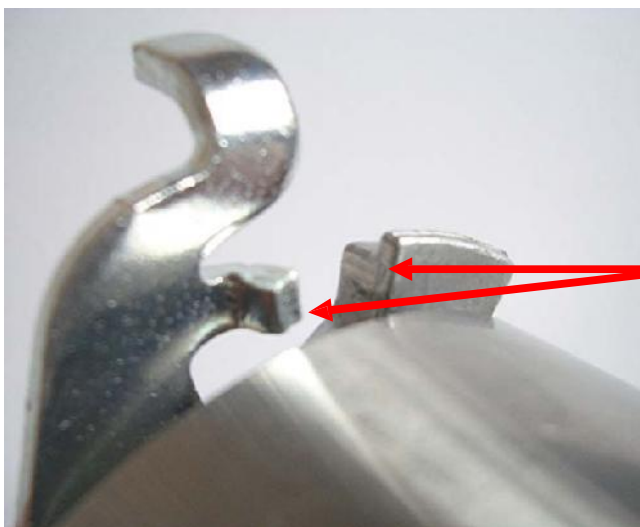
Remember that rotating the tensioner bearing in the wrong direction, with the hexagonal hole in the wrong starting position, without rotating the engine by two turns before and after adjusting the tension, may result in the tensioner arm striking at the end of the stroke and producing a hammering sound until it breaks. The abnormal tension created by this situation will lead to the inevitable collapse of the timing belt.

The presence of damages on these surfaces indicates an abnormal operation of the tensioner following an incorrect assembly.

The incidence of bolt breakage after fitment is due to correct installation procedure not being followed and will not be covered under Dayco warranty.
