DAYCO AFTERMARKET TECHNICAL INFORMATION

Mitsubishi I4 Timing Drive

T00017

Eng Code: 4G63, 4G64, 4G69 etc

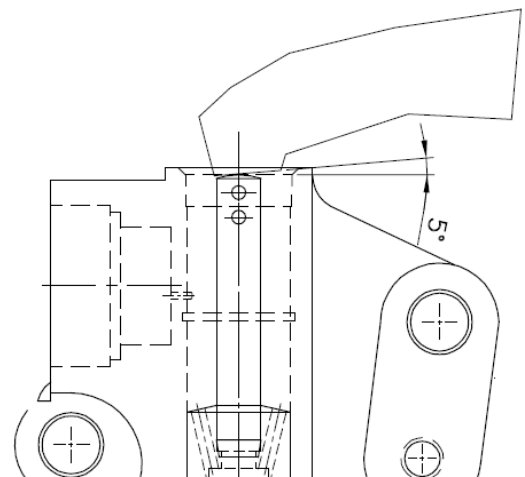
Incorrect Position

If these procedures and SST's are not used, the hydraulic actuator may operate in a range that will not provide the correct tension to the belt. This could cause a timing drive that either becomes noisy in operation or allows the drive to become unstable and lose timing or ultimately lead to failure of the timing drive.

It is also essential that the correct special service tools (SST) referred to in the vehicle manufacturer's procedures are used. This will ensure that the tensioner pulley is set to the correct position in order for the HAT to operate in its intended working range. The correct position for the tensioner actuator should sit such that the interface between the actuator rod and tensioner arm is perpendicular to the direction of travel of the rod. An example of correct and incorrect position is shown below.

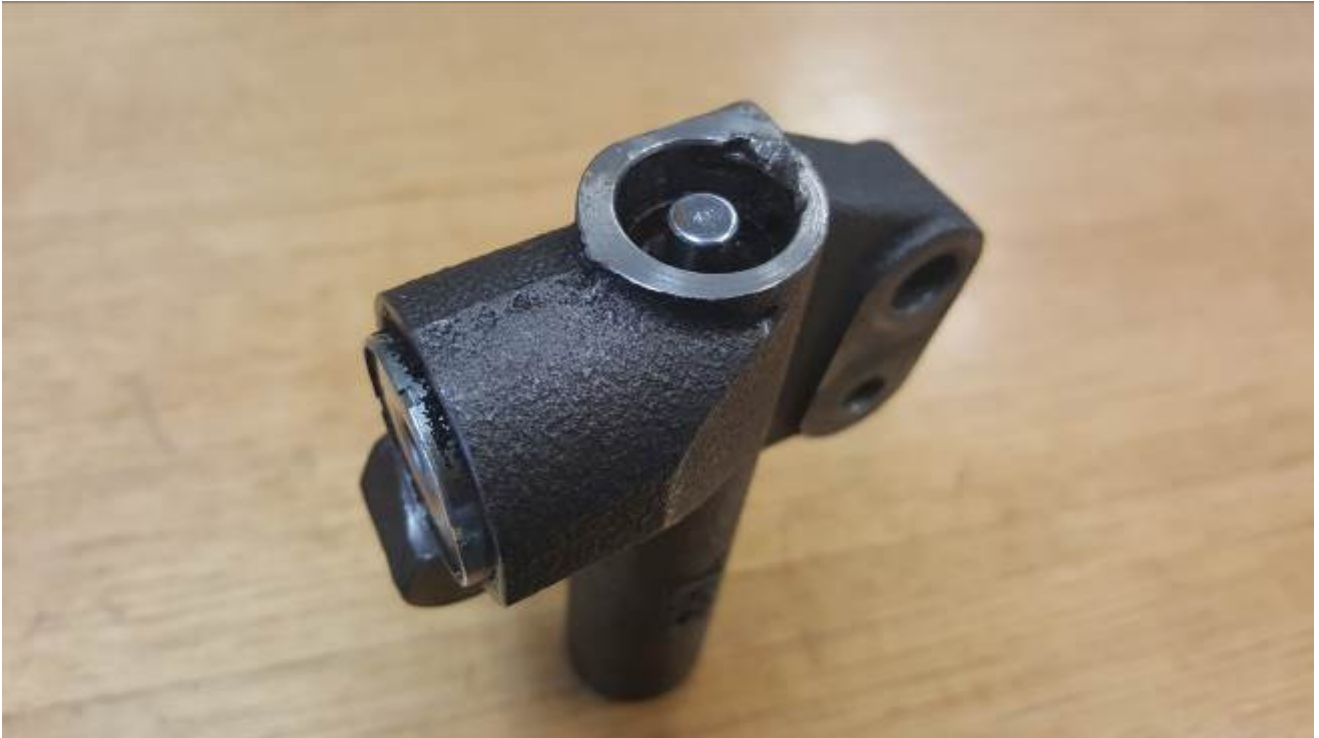
Evidence of HAT failures are actuator rods jammed in retracted position, and hammer marks around the HAT body where the tensioner assembly has come into contact with it. Example of which is shown above.
