## DAYCO AFTERMARKET TECHNICAL INFORMATION

**KTBA008 Tensioner Fitment Daewoo, Holden**

**T00005**

**Engines: A15MF Nubira, A16DMS Cielo & Nubira, F16D3 Barina**

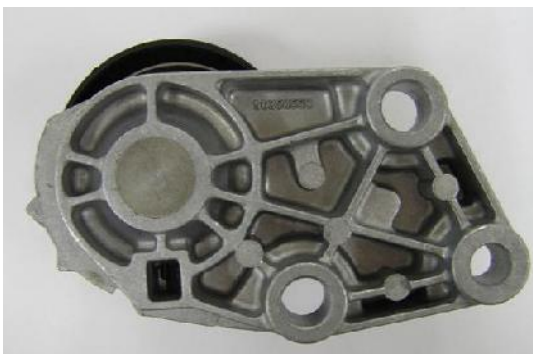
### Signs of incorrect tension procedure on returned product

1. Broken tensioner indicator Tab.
2. Witness marks on tensioner end stops.
3. Uneven wear or cracking on outer edge of the pulley surface indicating incorrect tension leading to premature failure.

**ALL adjustments are to be made via the water pump.**

Ensure that the tension indicator is lined up as per the vehicle manufacturer's specification on the automatic timing belt tensioner. This is essential in generating the correct amount of tension on the timing belt.

**Any type of lever or retaining devices that make contact with the automatic timing belt tensioner may result in premature FAILURE. This can then lead to catastrophic ENGINE FAILURE! Any attempt to lever the Automatic Timing Belt Tensioner will VOID ALL DAYCO TIMING BELT KIT WARRANTY.**
