DAYCO AFTERMARKET TECHNICAL INFORMATION

T00001

TENSIONER ASSEMBLY
KTBA005, KTBA093, KTBA122, KTBA142,
KTBA149, KTBA244
ENGINES GM 1.6, 1.8 , 2.0 , 2.2

Motorisations: C16SEL, C16XE, X16XE, X16XEL, Z16XE, Z16XEP, C18XE, C18XEL, X18XE, X18XE1, Z18XE, Z18XEL, X20XE, X22SE, X22XE, Y22SE.

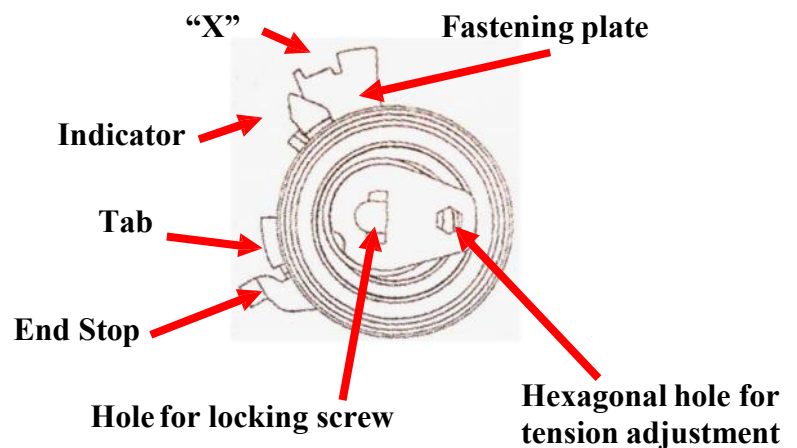
These kits contain mechanical automatic tensioners of the **type shown in the figure**, with a few dimensional differences according to the motorisation.
