DAYCO AFTERMARKET TECHNICAL INFORMATION

Mitsubishi V6 Timing Drive

T00016

Eng Code: 6G72, 6G74, 6G75

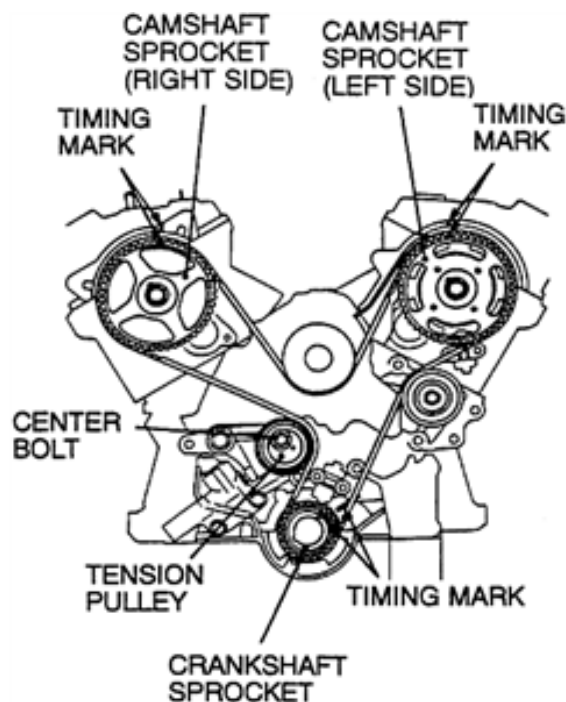
The Timing Drive on the Mitsubishi V6 family of engines (6G72, 6G74 and 6G75) incorporates a hydraulic automatic tensioner (HAT) to maintain tension on the timing belt. A typical example of the V6 timing drive with HAT is shown below.

Example of a Mitsubishi V6 Timing Drive

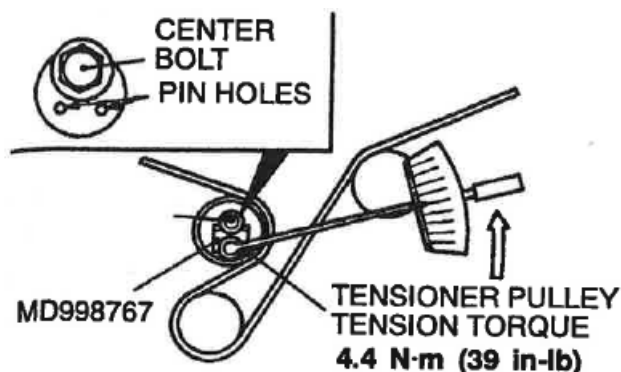
Special Service Tool (MD998767) used to set the Tensioner Idler Pulley in correct position

It is also essential that the correct special service tools (SST) referred to in the vehicle manufacturer's procedures are used. This will ensure that the tensioner pulley is set to the correct position in order for the HAT to operate in its intended working range.

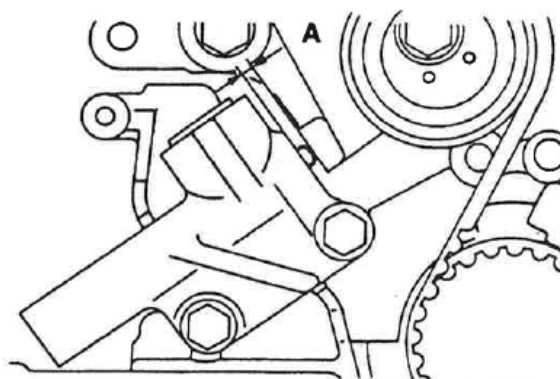
Dimension "A" as per vehicle manufacturer's procedures (dependent on actual vehicle application)

If these procedures and SST's are not used, the hydraulic actuator may operate in a range that will not provide the correct tension to the belt. This could cause a timing drive that either becomes noisy in operation or allows the drive to become unstable and lose timing or ultimately lead to failure of the timing drive.
